# **Whitehorse**

## **Vehicle Emissions Testing Clinic**

**June 4<sup>th</sup> and 5<sup>th</sup> 2009**

### **Final Report**

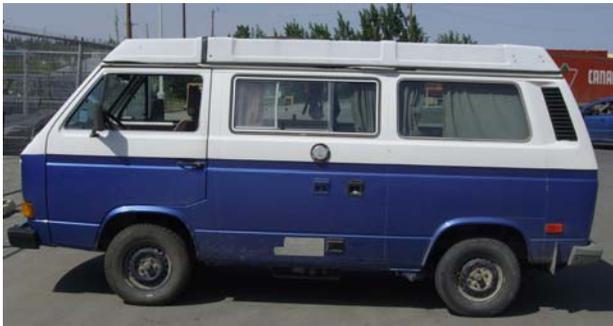
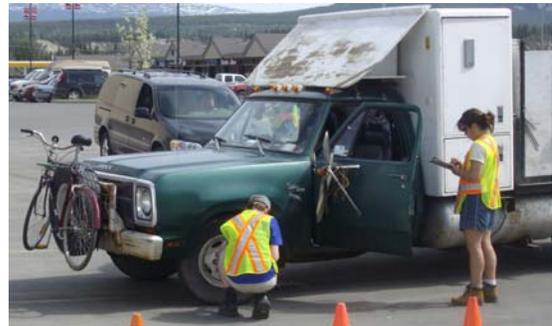
The other two vehicles that stood out as particularly high emitters were a 1984 Volkswagen Vanagon and a 1980 Dodge truck running on propane. The VW Vanagon had very high CO and HC readings at the tailpipe. It also had a gross exhaust leak just upstream of the catalytic converter that caused the readings to be greatly diluted (as indicated by very high O2 concentrations), so the actual HC and CO concentrations from the engine would have been 2 or 3 times what was measured at the tailpipe. Fortunately this vehicle is not usually driven. Even so, considering that its emissions are likely 100 times the level expected from a new car or truck, even driving it 200 km a year will produce the same HC and CO emissions as 20,000km in a 2009 model year vehicle.

The owner of the propane Dodge truck claimed to have converted to propane 'for the environment'. The truck's emission controls were all disabled or removed, although this might have happened before the conversion. It was once common to remove emission components as part of propane conversions, but this was in the entirely incorrect belief that they were no longer needed when running on propane. In the Vancouver area, all such conversions very quickly failed their emission inspections as soon as the AirCare Program started in 1992, and now there are very few propane vehicles still operating in the region. This particular truck had extremely high HC emissions (unburned fuel in the exhaust) - more than twice as high as any other vehicle tested, as well as very high CO.
