WIND POWER DEVELOPMENT IN SUB-ARCTIC CONDITIONS WITH SEVERE RIME ICING

John F. Maissan, P.Eng.,
Director, Technical Services
Yukon Energy Corporation

Circumpolar Climate Change Summit and Exposition

March 19-21, 2001
Whitehorse, Yukon
Canada

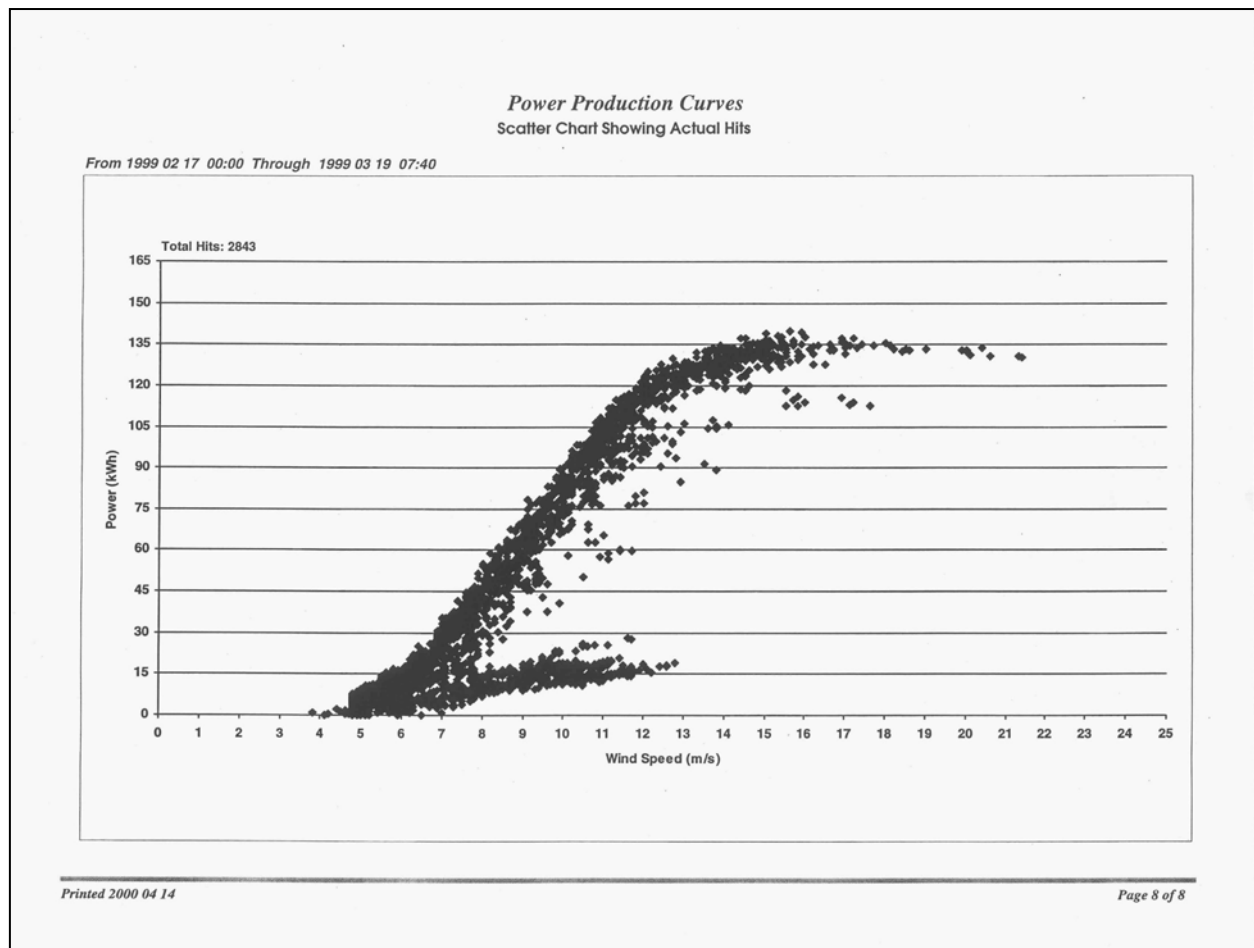
Graph 1 Rime Icing Effects on Power Production Curves

The effect of rime icing on the blades of the wind turbine is such an important issue that it is worth examining in detail. Without blade heaters rime ice builds up especially heavily on the leading edges, and the build up increases with distance from the blade root (Photograph 4). It seems to be directly related to the velocity at any point and therefore perhaps the amount of moisture or moist ice contacted. When shut down the ice builds up on the edges of the blade surface facing the wind, the pressure side. When running through an icing event the ice build up on the "back", or suction side, of the blade is much less than on the "front" (Photograph 5). Ice can also build up on the trailing edge. Power production drops off dramatically when the blades are coated with rime ice and without leading edge blade heaters can stop altogether (Graph 1).

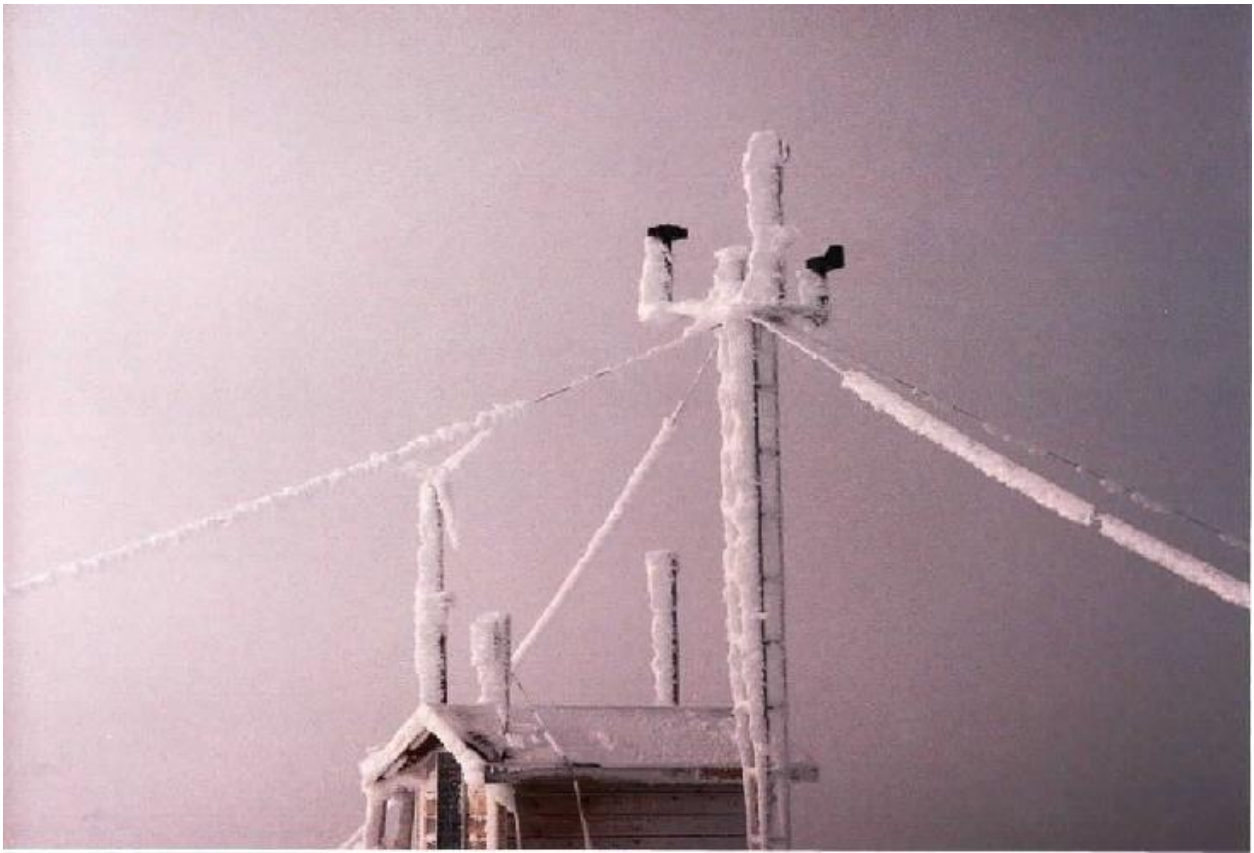
The climate in Whitehorse is sub-arctic, mean daily January lows are -25°C with the lowest temperatures around -40°C , and occasionally to -45°C or lower. Weather data analyses have shown that at altitudes of 4,000 to 6,000 feet rime icing can occur from 800 to 1200 hours per year -- equivalent to a continuous duration of 4 to 7 weeks per year. Rime icing is the buildup of ice on anything solid from moist, supersaturated air at sub-zero temperatures. Essentially whenever and wherever there is a cloud on a mountain there is rime icing (cover photograph). Rime ice looks like the pretty frost that builds up on trees around open water in the winter. In our location rime icing is most severe in the early winter: mid October to the end of December. Severe rime ice on wind monitoring equipment is illustrated in Photograph 1.

Photograph 1: Rime ice on monitoring equipment, only heated instruments stay clear

1. The heated bearing anemometer and wind vane were still immobilized by ice and were replaced with fully heated Hydro-Tech instruments which have not iced up (Photograph 1).
2. The overhead power line was causing about five outages per month due to the heavy accumulation of ice in combination with wind, and was replaced with a buried cable which is not affected by the ice.

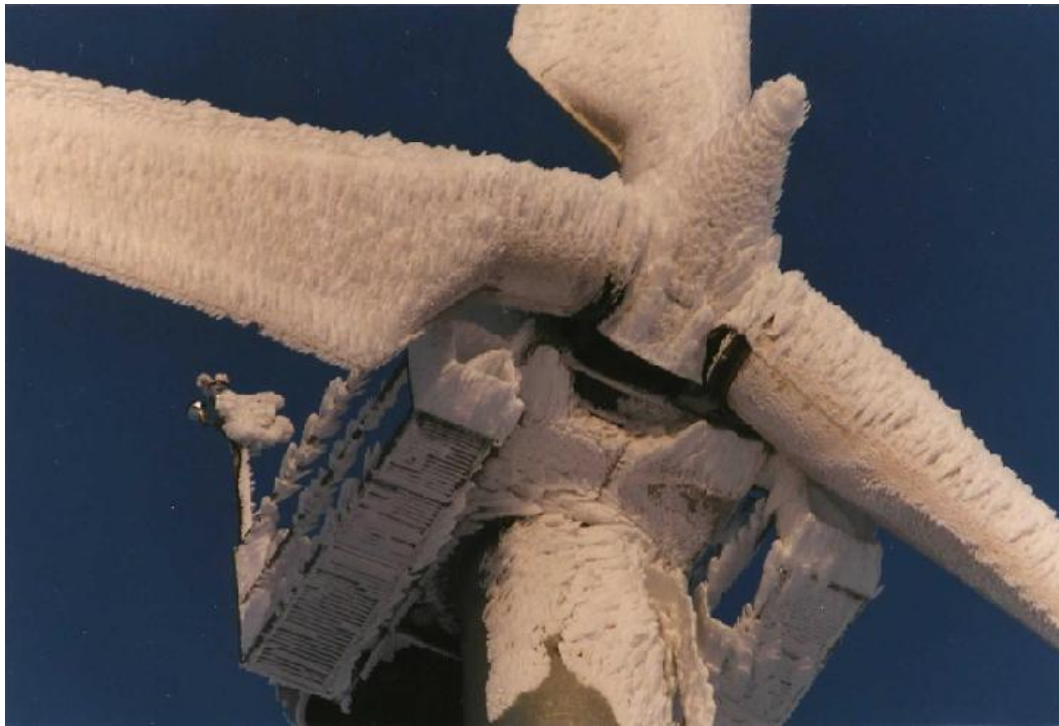
Rime icing causes were briefly described in the introduction. The practical effects can be substantial. Any solid object accumulates ice which “grows” into the wind (Photograph 3). Trees become ice domes, towers become ice posts, power lines grow to six or eight inches in diameter, and chain link fences become solid walls. As you can see it is no wonder that exposed equipment has difficulty working under these conditions. Low temperatures and severe rime icing are the challenges we need to overcome.

Photograph 3: turbine heavily iced, did not run through icing period

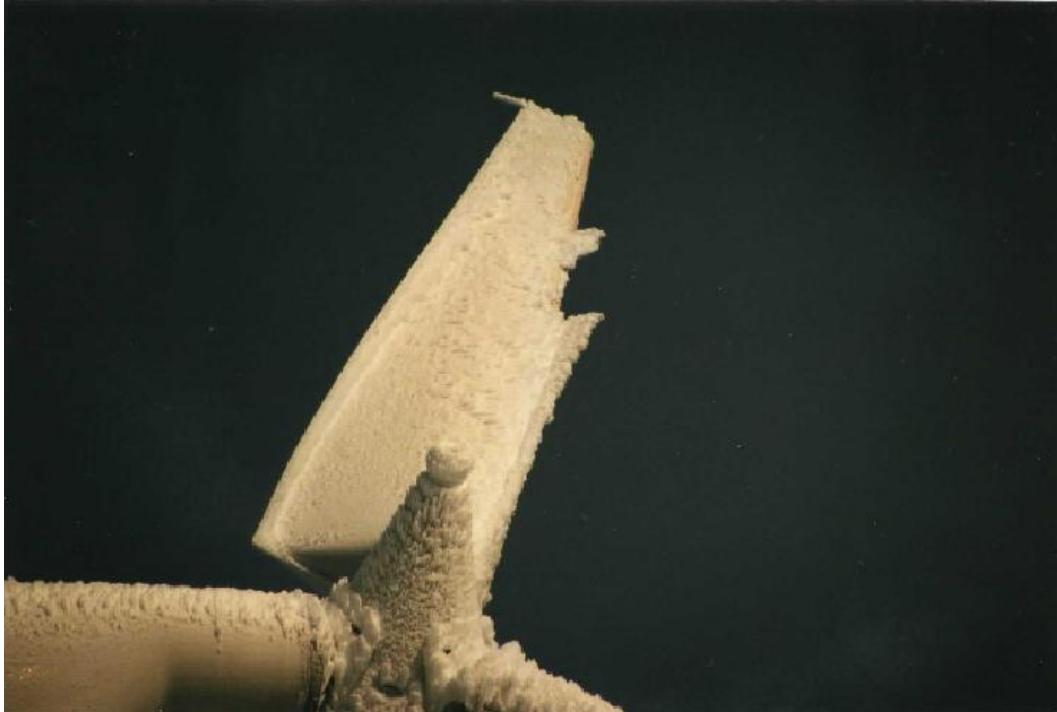
Photograph 4: wedge shaped ice builds up on the blades when running through icing events – leading edge heaters not working

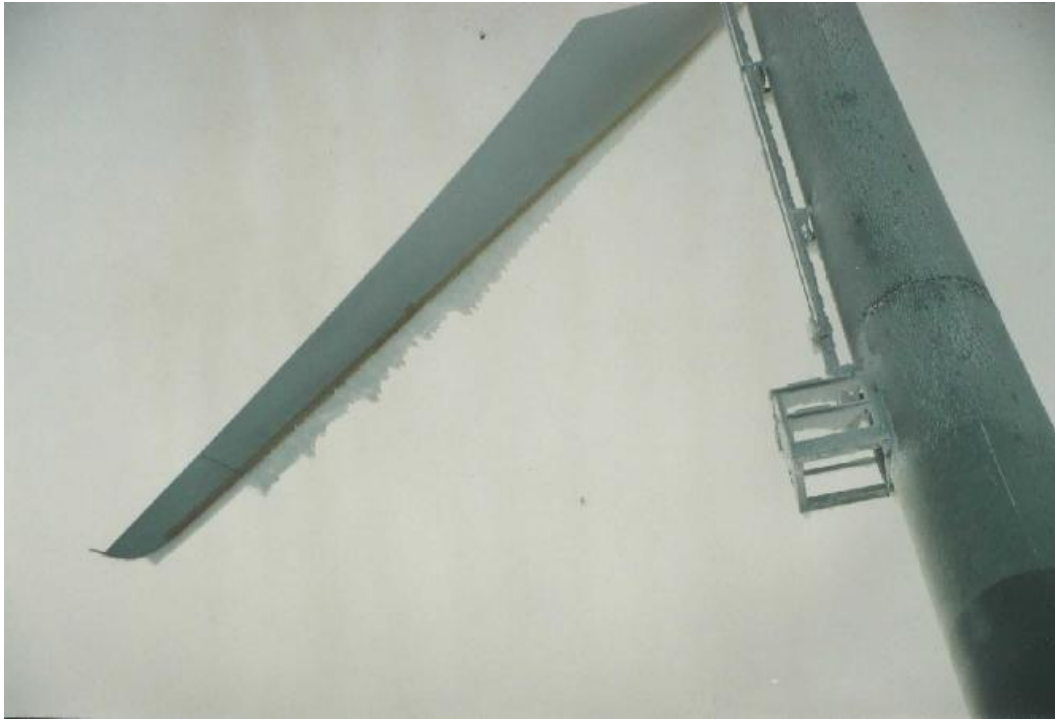
Photograph 5: wedge shape build up from back, note clear back of blade – leading edge heaters not working

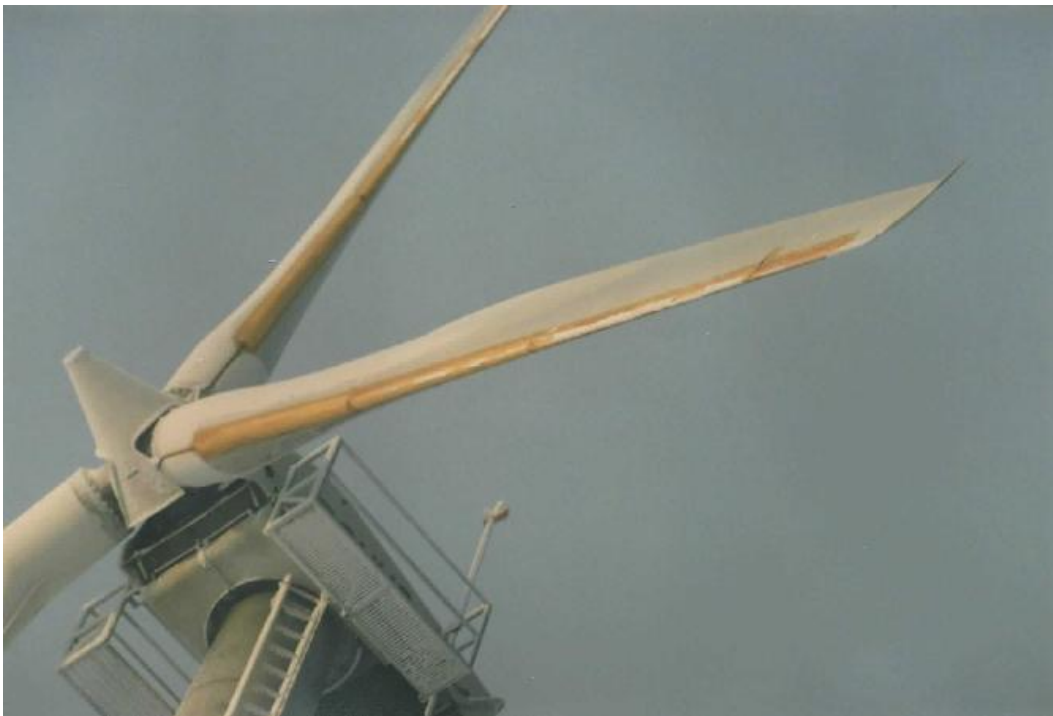
The 6 inch wide heaters did, under lighter icing conditions, keep portions of the blade downwind of the heater clear (Photograph 6). Under heavier icing conditions ice would build up on the blade right up to the heater (Photograph 7). Build up of ice on the leading edges did not occur except under the most severe conditions, and it cleared off quite quickly afterwards. It was from this that we concluded that more heat on the front of the blade in the form of wider leading edge heaters would be of benefit if the increased area was applied to the front (pressure side) of the blade. It was also obvious that the leading edges of the blade tip would need to be heated to minimize the air drag and associated production losses.

Photograph 6: in less severe rime icing the effect of the leading edge heaters extends past the leading edge

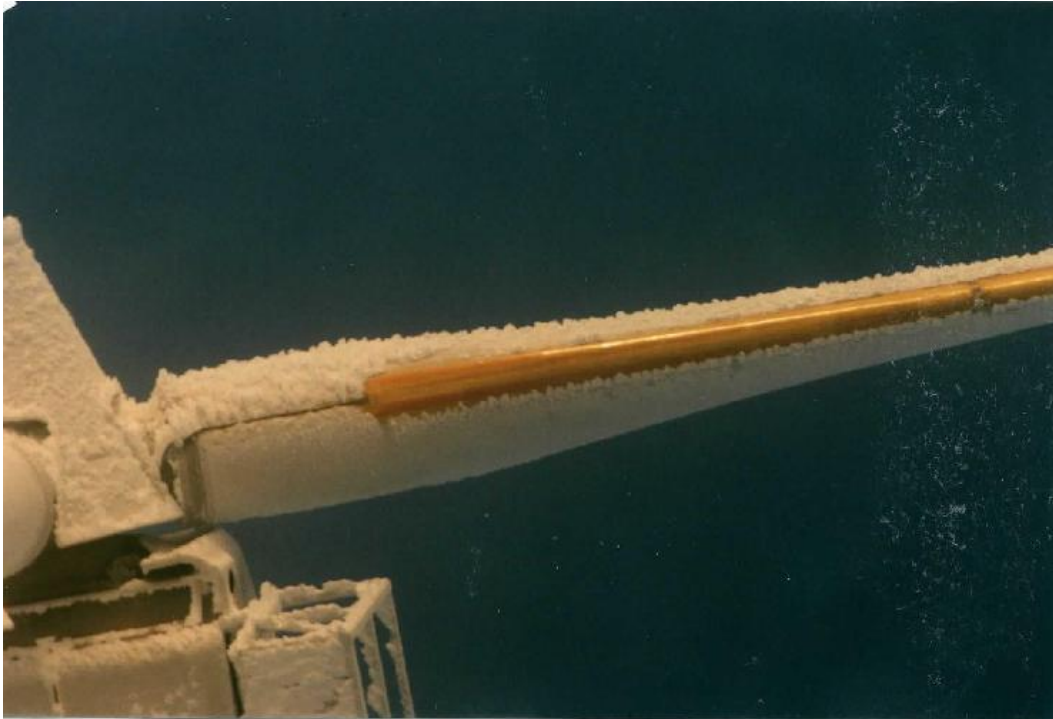
Photograph 7: in severe icing conditions the effect of the leading edge heaters does not extend as far

The leading edge blade heaters (1/4 watt per square inch) have worked reasonably well even though one burnt out in 1996. We replaced them all in 1998 with heaters 12 inches wide, rather than 6 inches, to improve performance in very severe rime icing and in very cold temperature conditions. Perhaps because of other problems and advances we have not been able to attribute specific production improvements to the larger heaters.

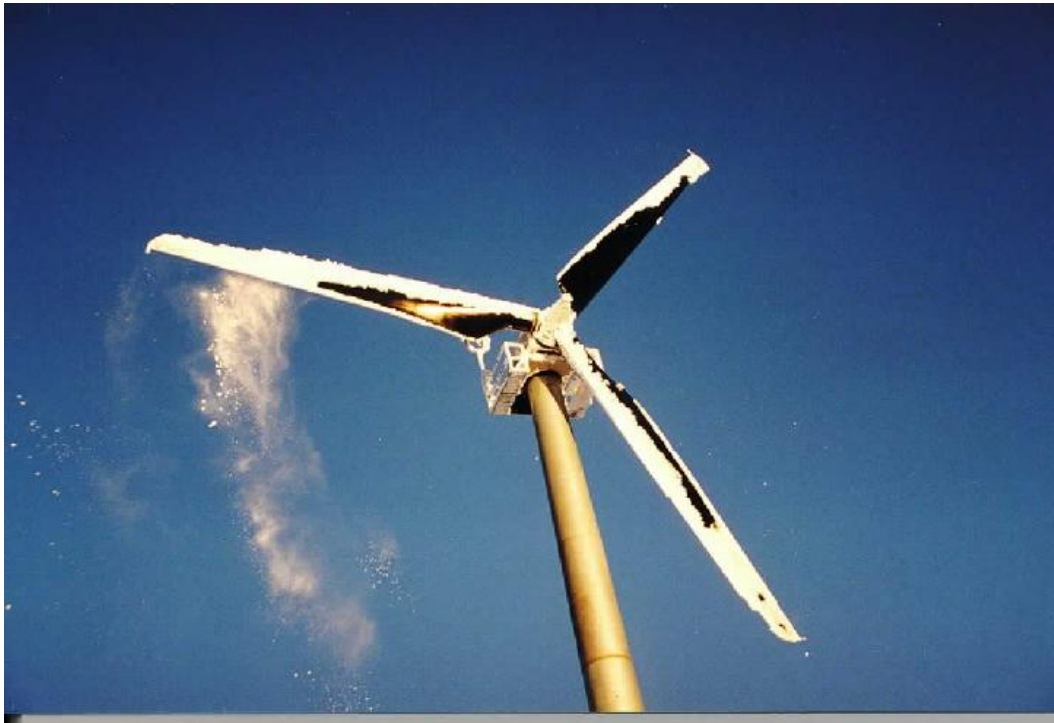
Repairs to the power line (a local feeder) were made in 1996 and since that time there have been very few of the electronic problems that bothered us early on, and turbine availability has been very high. Also in 1996 we "painted" the blades with a black coloured coating called StaClean. We believed that the solar heating from the black colour would assist in clearing the blades of accumulated rime ice, and we felt that the special low adhesion formula for ice could be beneficial too. We saw an immediate noticeable improvement in performance, 1998 and 1999 have been the best production years yet. Photograph 8 shows accumulated ice shedding from the blades.

Photograph 8: accumulated ice shedding from black blades
