Case Study #8 Nijmegen Road

SUMMARY: This profile features a duplex (Figure 1) built by a contractor-designer who incorporated old, simple, high-quality ideas with SuperGreen energy-efficiency. This is the first Leadership in Energy and Environmental Design (LEED) Canada for Homes certified project in Yukon. The wall design is a 38x89 mm (2x4 in.) double stud wall filled with low-density spray foam insulation. The house has electric heat, but also incorporates thermal storage in the basement floor to reduce electrical peaks on the grid.

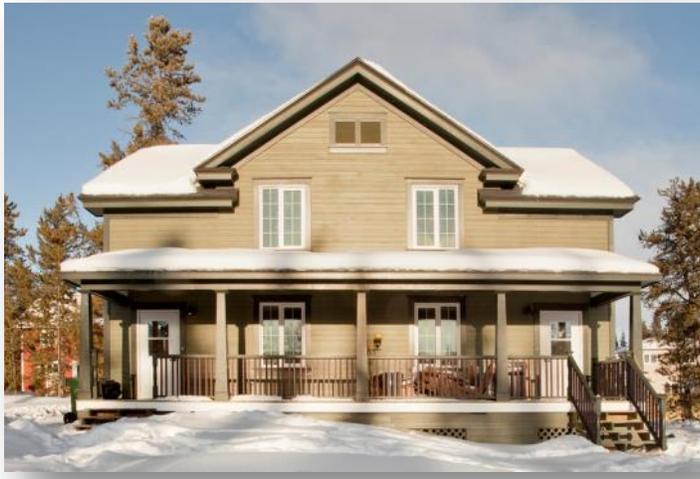
Figure 1: SuperGreen House, Whitehorse, Yukon

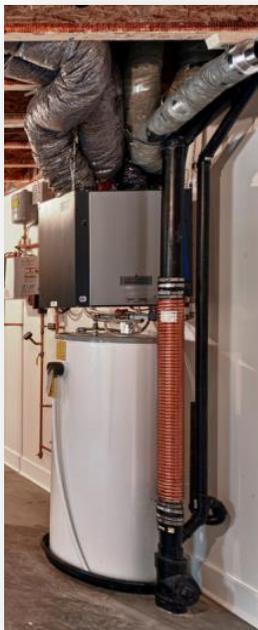
- Hot water: Electric convector tank with drain water heat recovery on main drain line (Figure 3).
- Renewable energy system: Provisions were made for solar photovoltaic (PV) and solar hot water, but systems are not installed at this time. This included installing chases from the attic to the basement for solar hot water lines plus pre-wiring from the attic to the electrical panel area for future solar PV. The long-axis of the house is East-West with the roof slope oriented south to facilitate the installation of solar PV or thermal

Figure 3: Hot water

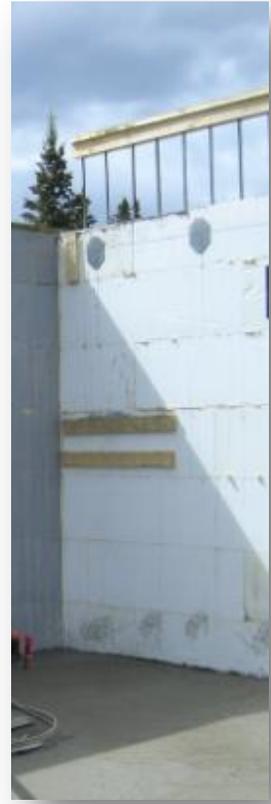
Figure 4: ICF detail

Next time, this builder would use the same design (ICF) for the foundation walls - resilient, strong, fast, easy to work on (Figure 4). They would also use the same method for the floor. As well, they were very happy with using blown cellulose for ceiling insulation. It is inexpensive to install and effective.
