Case Study #9 Phoenix Rising

SUMMARY: This profile features the first of Habitat for Humanity's (HFH) SuperGreen houses built in the Yukon. They began constructing this triplex after Yukon Housing Corporation (YHC) built their first SuperGreen houses. HFH is a non-profit organization that builds houses for families in need, who are not eligible for a conventional mortgage. The family must have lived in the Yukon for one year.

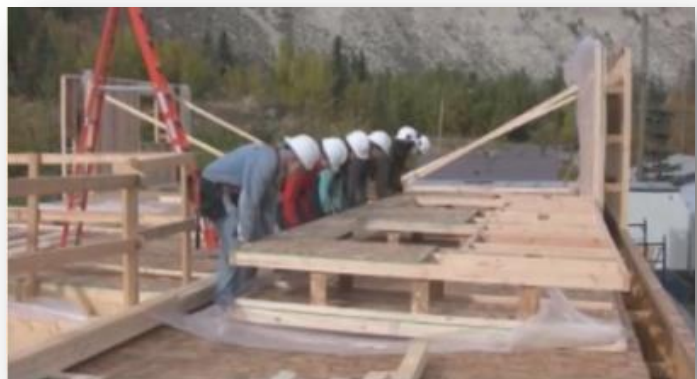
Figure 4: Larsen wall-truss system

They chose a Larsen wall-truss system (Figure 4) in order to completely wrap the building in a solid layer of cellulose insulation with no thermal bridging. However, while the builder liked the idea of it on a very simple box shaped building, if they were doing it again, he thinks the stand-off wall was perhaps a bit too deep and overall success depends upon the cellulose applicator's experience.

The cellulose settled in the wall leaving a gap at the top, so the walls had to be topped up during construction. Due to uncertainty with future cellulose settling, and the way HFH builds their houses - particularly using volunteer labour - this wall system is no longer used. Construction took somewhat more time than standard, partly due to the number and variety of experience of the people working on it.

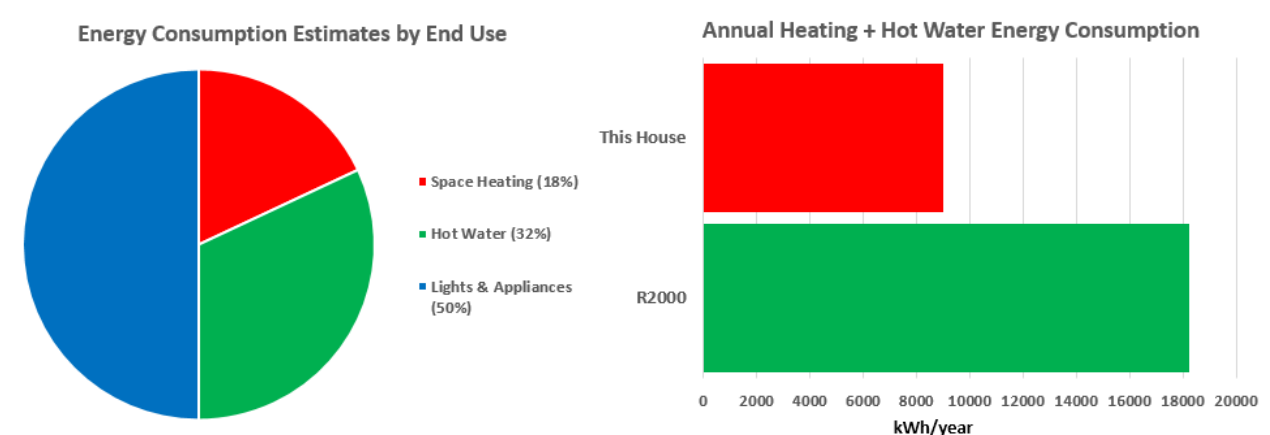
An EnerGuide rating is a measure of a home's energy performance. EnerGuide has been in place since the mid 1990's. It makes use of actual house parameters like insulation values, mechanical equipment efficiencies and air tightness in a computer energy simulation (Hot 2000) using standardised occupant conditions for plug in loads, hot water use and thermostat settings. The figure below shows the energy breakdown of this house.

EnerGuide Rating: 87

Project latitude	60.5°N
Annual heating degree day zone	>6000HDD°C
Mean January temperature	-16.2°C (2.8°F)
January heating design temperature	-41°C (-43°F)
Heating system design heat load	5.5 kW (18,766 BTU/h)
Main floor(s) heated area	130 m ² (1,404 ft ²)
Crawlspace heated area	65 m ² (702 ft ²)
Total liveable area	130 m ² (1,404 ft ²)
Building footprint (whole triplex)	217.7 m ² (2,344 ft ²)
Window area	21.2 m ² (228 ft ²)
% of windows facing south	38 %
Air leakage rate @ -50 Pa (<i>as operated</i>)	1.1 ach
Equivalent leakage area (hole size) @ -10 Pa (<i>as operated</i>)	136.1 cm ² (21.1 in ²)
Annual energy use per m ²	136 kWh/m ²
Projected total annual energy usage	17,726 kWh/yr
Actual performance as it compares to occupant bills	2% below projected averaged over a 4-year period
