# Whitehorse Emission Testing Clinic

September 20<sup>th</sup> and 21<sup>st</sup> 2007

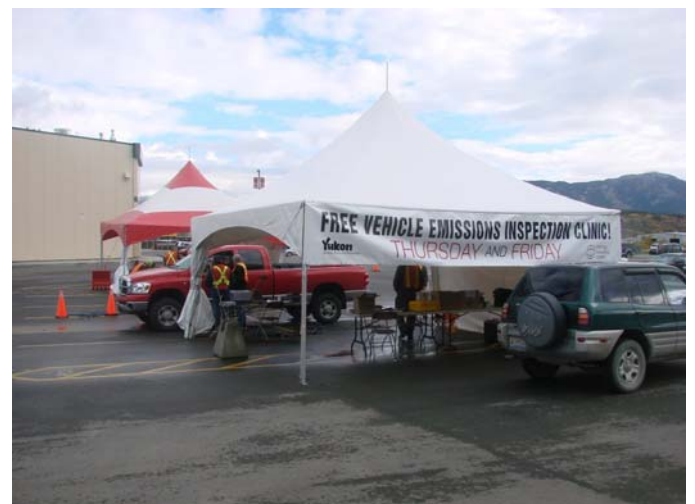
The clinic was held in the parking lot of the new Canadian Tire store in Whitehorse. The signage and operations were clearly visible from the main road leading to/from the Alaska Highway and Whitehorse Airport. Two complete inspection operations were set up, to provide two inspection 'lanes'. Power was provided from the Canadian Tire repair bays, and an air compressor was located between the lanes to inflate any tires that needed it.

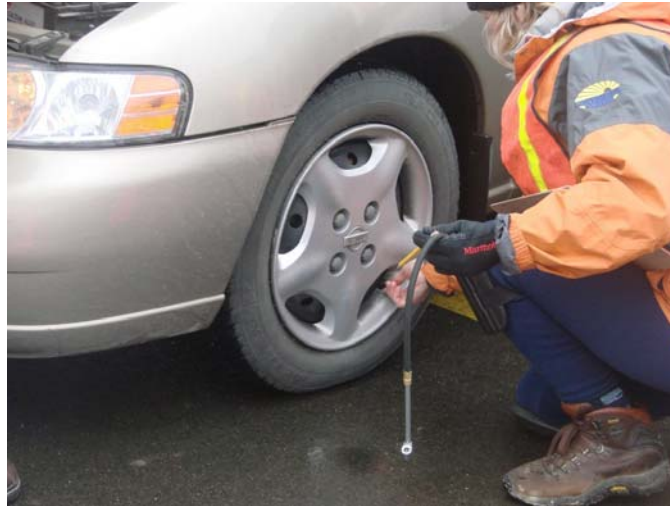
- **Tire Pressures** were checked using mechanical and digital gauges. However, the digital gauges were not completely reliable, and any future clinics will use all mechanical gauges. All four pressures were recorded; then, in consultation with the vehicle owner and after checking any information on the vehicle decals, the tires that needed it were brought up to the correct pressure.

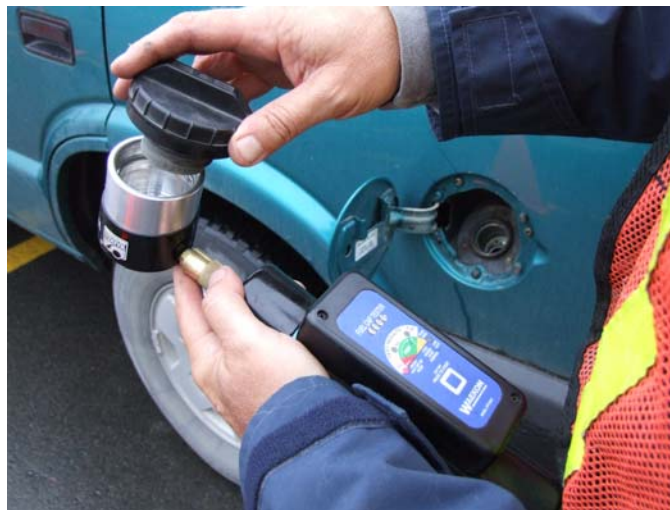
- **Gas Caps** on all 1997 and older vehicles were removed and pressure tested using Waekon hand-held testers. Diesel caps were not tested. Gas caps from 1998 and newer vehicles were not tested, because their proper operation is checked by the vehicle's OBD system.

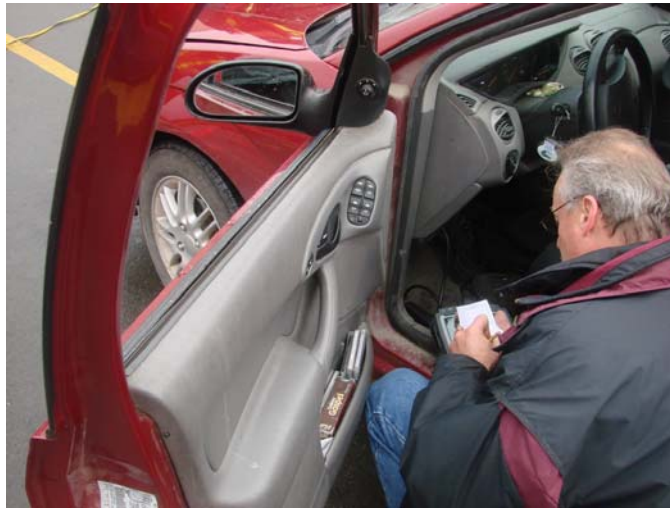
- **Emission Control System (ECS)** components were checked on all 1997 and older vehicles. In most cases this was with reference to the under hood emissions decal. The ECS components checked for were: Catalytic Converter; Positive Crankcase Ventilation (PCV); Exhaust Gas Recirculation (EGR) valve; Air Injection System (AIS); Thermostatic Air Cleaner (TAC); and Evaporative Canister.
- **The OBD Inspection** was conducted using a Genisys scanner made by OTC, connected to the Diagnostic Link Connector (DLC). It also included visual Key-On-Engine-Off (KOEO) and Key-

On-Engine-Running (KOER) Malfunction Indicator Lamp (MIL) checks. All monitors were recorded as 'ready', 'not ready', or 'not supported'. The MIL command status was checked, and any Diagnostic Trouble Codes (DTCs) were noted.

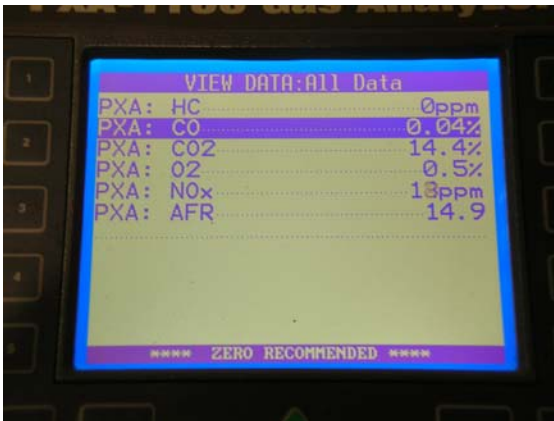
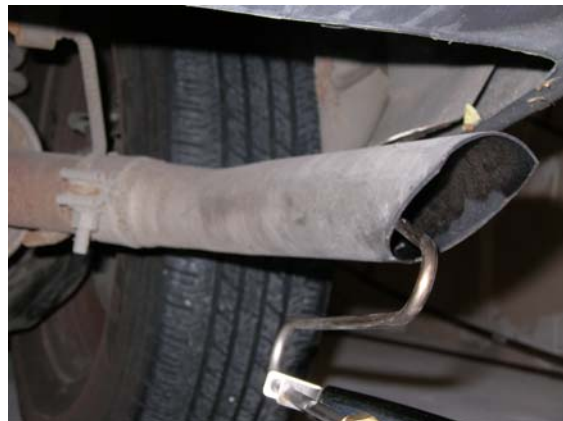
- **The Tailpipe Test** was a Two-Speed Idle: 2000 rpm followed by a curb idle. Concentration measurements were taken using a Vetronix portable 5-gas analyser. The cut points used to determine PASS or FAIL for the curb idle were the same as would be used for idle tests in the Aircare program: they varied by vehicle type, model year and engine size. For the 2000 rpm high idle the cut points were set at 220 parts per million (ppm) Hydrocarbons (HC) and 1.2% Carbon Monoxide (CO).

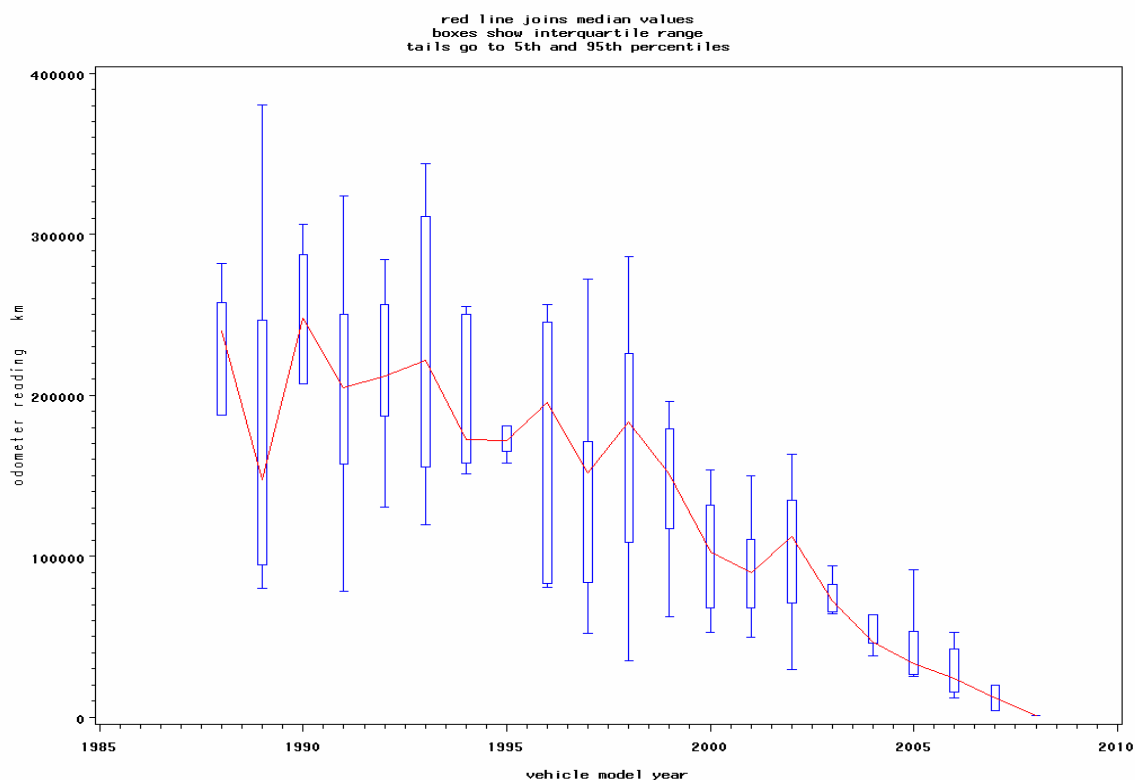
## Odometer Reading — Distribution by Model Year

The slope of the following chart suggests that annual mileage averages around 19,000 km/year over the first 10 years of life and then drops off a little. This is higher than in the Vancouver region, so in their first ten years of life vehicles in Whitehorse appear to be driven further than vehicles in Vancouver.

<sup>1</sup> The 800,000 km vehicle was a taxi on its third engine, and can be considered an outlier.

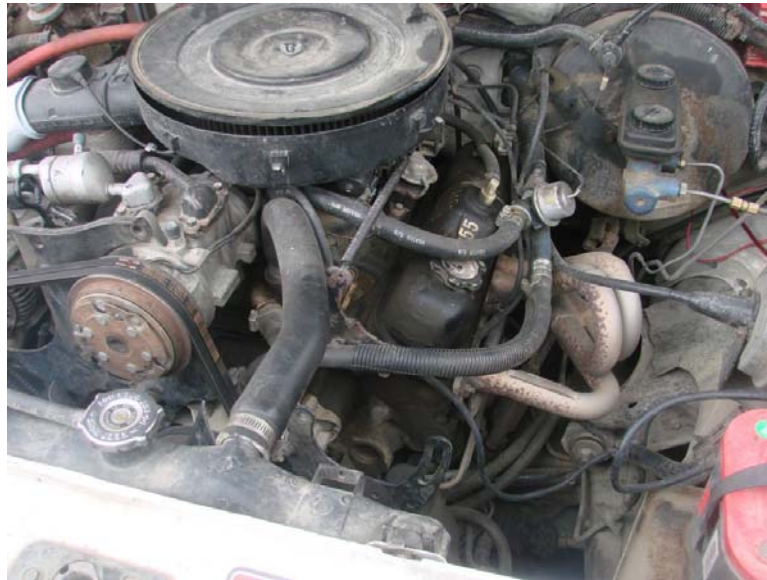
The inspections did not reveal much evidence of intentional tampering. Only two gasoline vehicles were identified as definitely tampered. They were a 1988 Dodge Dakota, where all Emission Control System (ECS) components had been tampered (pictured below) and a 1991 Audi with a tampered Exhaust Gas Recirculation (EGR) valve.
